SIMPLEX SERVICE BULLETIN

NO. 54281

RP120A & RP120B RAIL PULLER

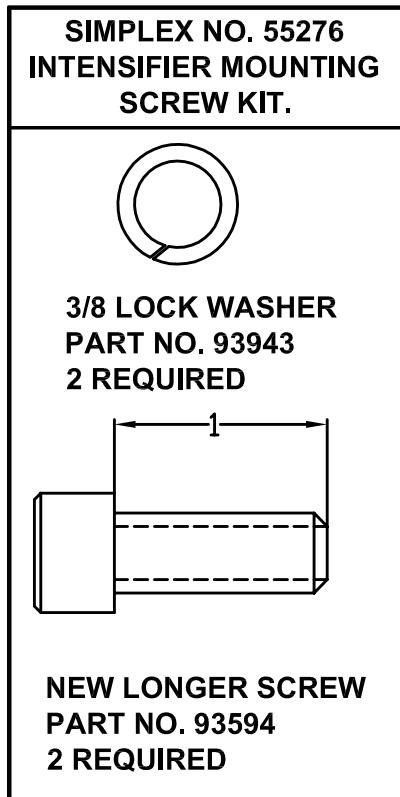
PROBLEM: INTENSIFIER MOUNTING BOLTS BECOME LOOSE AND FALL OUT OR DAMAGE MOUNTING HOLES IN THE INTENSIFIER MANIFOLD.

CAUSE: LACK OF LOCK WASHERS ON MOUNTING SCREWS AND MOUNTING SCREWS THAT ARE TOO SHORT.

SOLUTION: REPLACE MOUNTING SCREWS WITH ONES THAT ARE 1/4 INCH LONGER AND ADD LOCK WASHERS WITH SIMPLEX KIT NO. 55276 .

REMOVE AND REPLACE OLD MOUNTING SCREWS WITH NEW LONGER SCREWS AND LOCK WASHERS FROM THE REPLACEMENT KIT PART NO. 55276. REPLACE ONE SCREW AT A TIME TO KEEP INTENSIFIER IN POSITION ON PULLER. TORQUE MOUNTING BOLTS TO 240 INCH POUNDS.
