# **SIMPLEX SERVICE BULLETIN**

## **RP120A & RP120B**

### **RAIL PULLER**

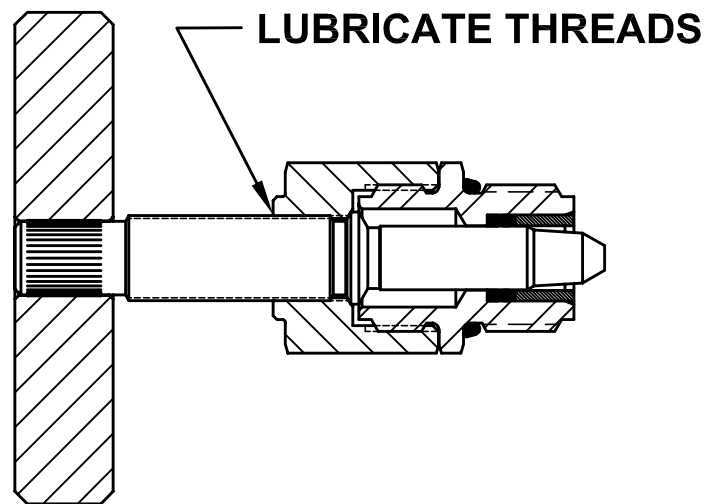
**PROBLEM: NEEDLE VALVE ASSEMBLY # 41183 USED ON INTENSIFIER AND LOAD LOCK VALVE SEIZES PREVENTING KNOB FROM TURNING.**

**CAUSE: LACK OF LUBRICATION DURING ASSEMBLY AND / OR DAMAGED THREADS ON VALVE ADJUSTING SCREW.**

**SOLUTION: CHECK NEEDLE VALVE ASSEMBLIES FOR EASY ROTATION IN OPEN POSITION WITHOUT HYDRAULIC PRESSURE. LUBRICATE WITH PENETRATING ANTI-SEIZE LUBRICANT INDUSTRY- RAILWAY PART NO. 80208.**
